SOIL MANAGEMENT PLAN

International Marine Terminal Site
West Commercial Street
Portland, Maine

Prepared for:
MaineDOT
Augusta, Maine

Amended by:
Haley & Aldrich, Inc.
Portland, Maine

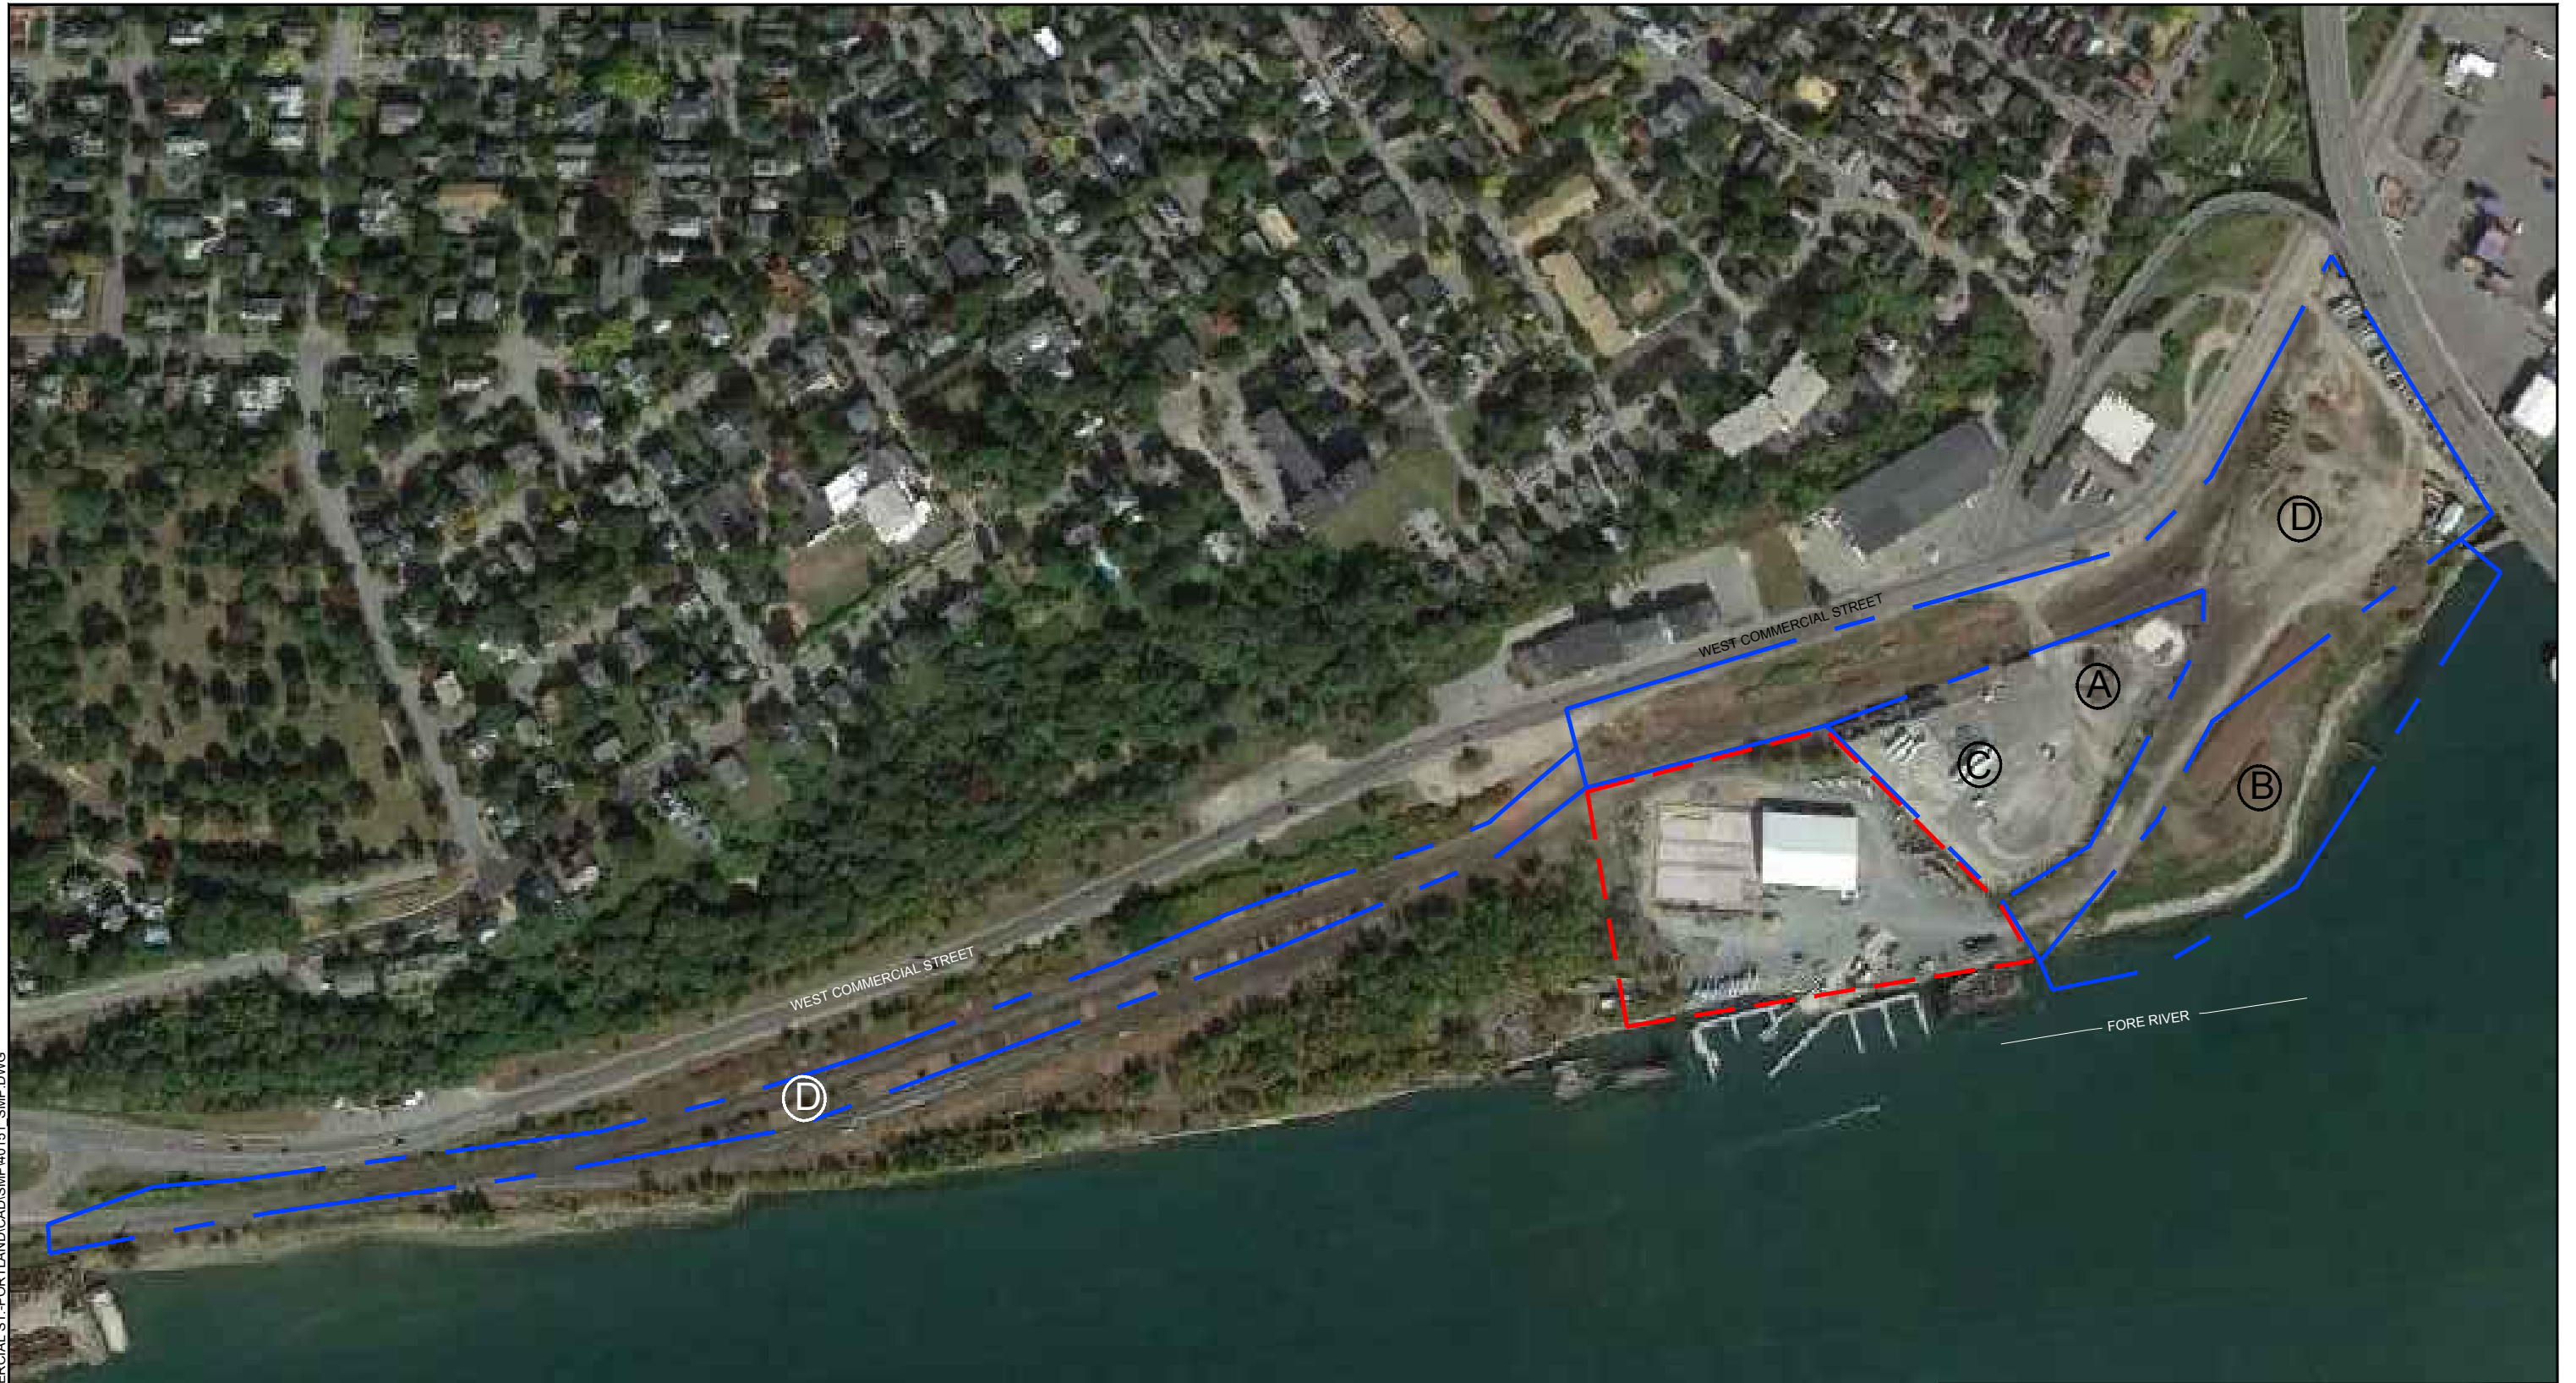
FIGURE 2

The acquired eastern Pan Am property extends from the Casco Bay Bridge with two finger-like extensions to the west; the southern extension includes the property between the two Unitil parcels; and the northern finger extending from the northern boundary of the Inland Unitil parcel to West Commercial Street continuing in a westerly direction to the northwest corner of the New Yard, LLC property (see Figure 2). The acquired western Pan Am parcel is approximately 50 to 100 ft in width extending from the intersection of Cassidy Point Drive and West Commercial Street to the west, traversing in an easterly direction parallel to West Commercial Street extending to the western boundary of the New Yard LLC property and the above-mentioned Pan Am parcel (see Figure 2).

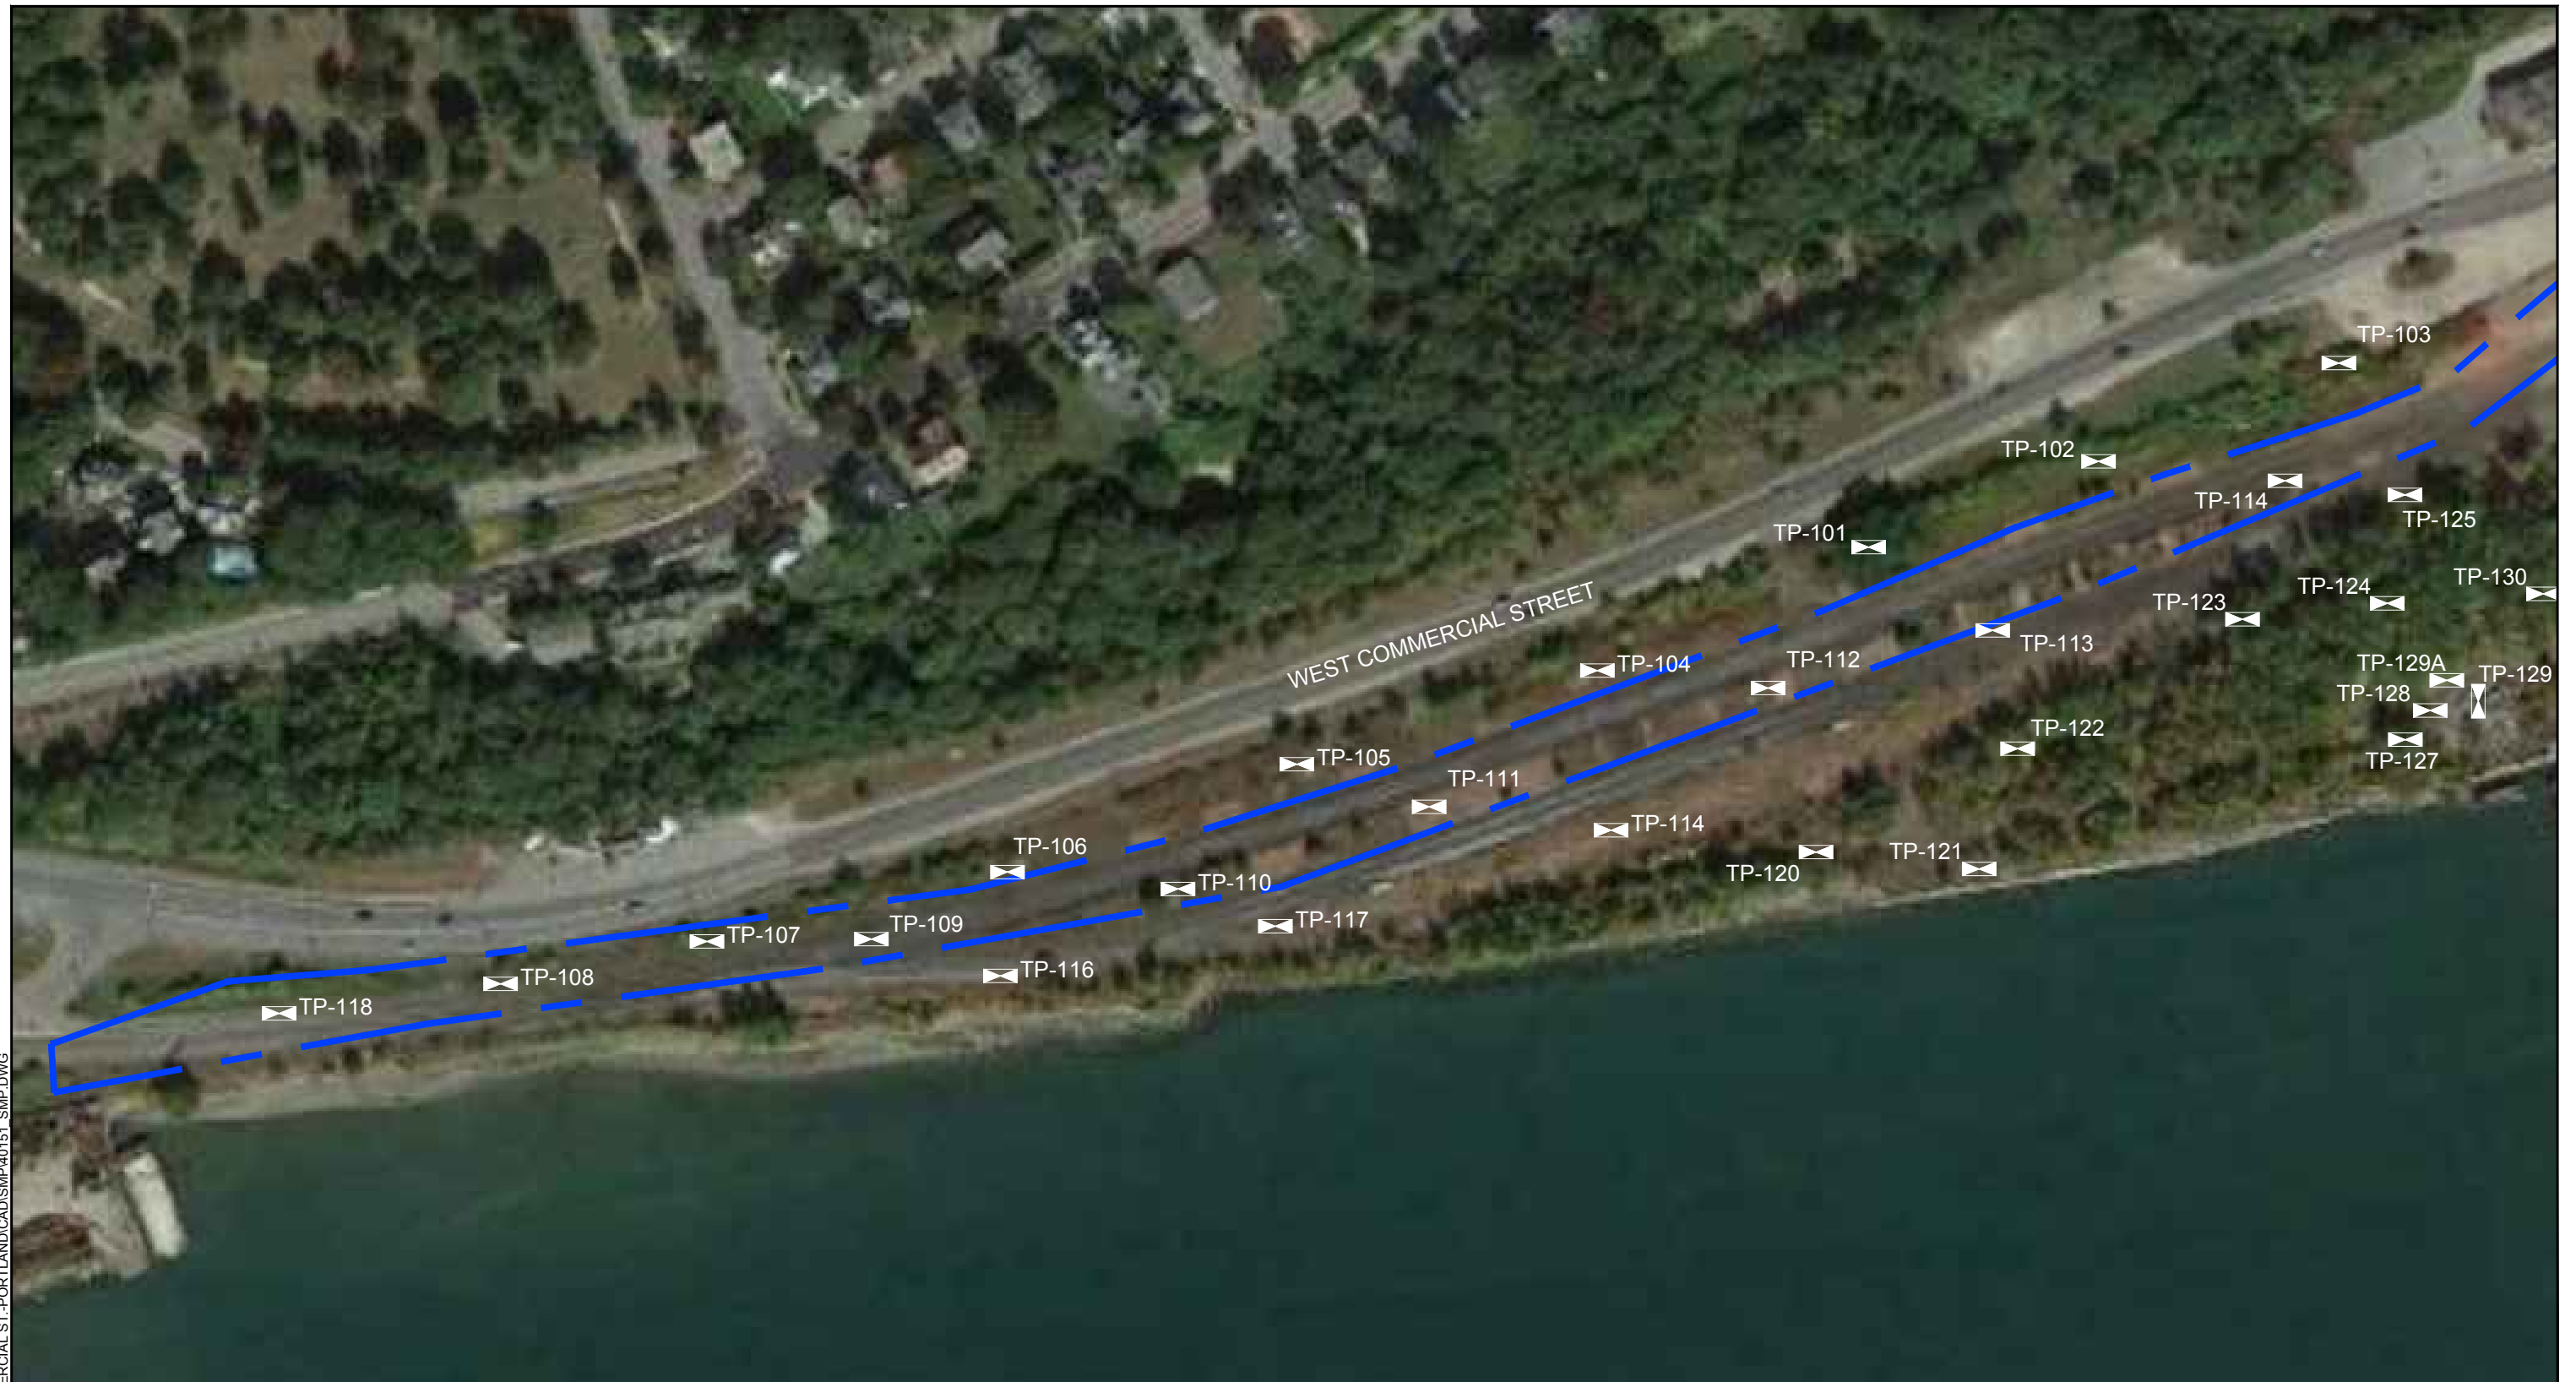
FIGURE 3

As part of the Phase II ESA, a series of test pit excavations were performed to investigate subsurface conditions beneath this portion of the Pan Am property. The thirty-six completed test pit excavations, designated TP-101 through TP-136, are shown on Figure 3 (2 sheets). The purpose of the test pits was to assess the degree and extent of anticipated fill material and potential environmental impacts associated with past railroad operations and adjoining property uses. In addition, selected soil samples collected from the excavations were submitted for chemical analyses.

1. BASE PLAN OBTAINED FROM GOOGLE EARTH, US DEPT. OF STATE GEOGRAPHER, 2013 GOOGLE.
2. TEST PIT EXCAVATIONS WERE PERFORMED BY MACKENZIE CONSTRUCTION OF WINSLOW, MAINE BETWEEN 19 AND 23 AUGUST 2013. ALL EXPLORATIONS WERE MONITORED BY HALEY & ALDRICH PERSONNEL.
3. TEST PIT LOCATIONS ARE APPROXIMATE AND WERE DETERMINED BY TAPING/PACING DISTANCES FROM EXISTING SITE FEATURES.
4. DESIGNATED PROPERTY BOUNDARIES WERE DETERMINED FROM "BOUNDARY & TOPOGRAPHIC SURVEY, WEST COMMERCIAL STREET," DATED 4 APRIL 2014 PREPARED BY OWEN HESKELL, INC. FOR HNTB & MAINE DOT.

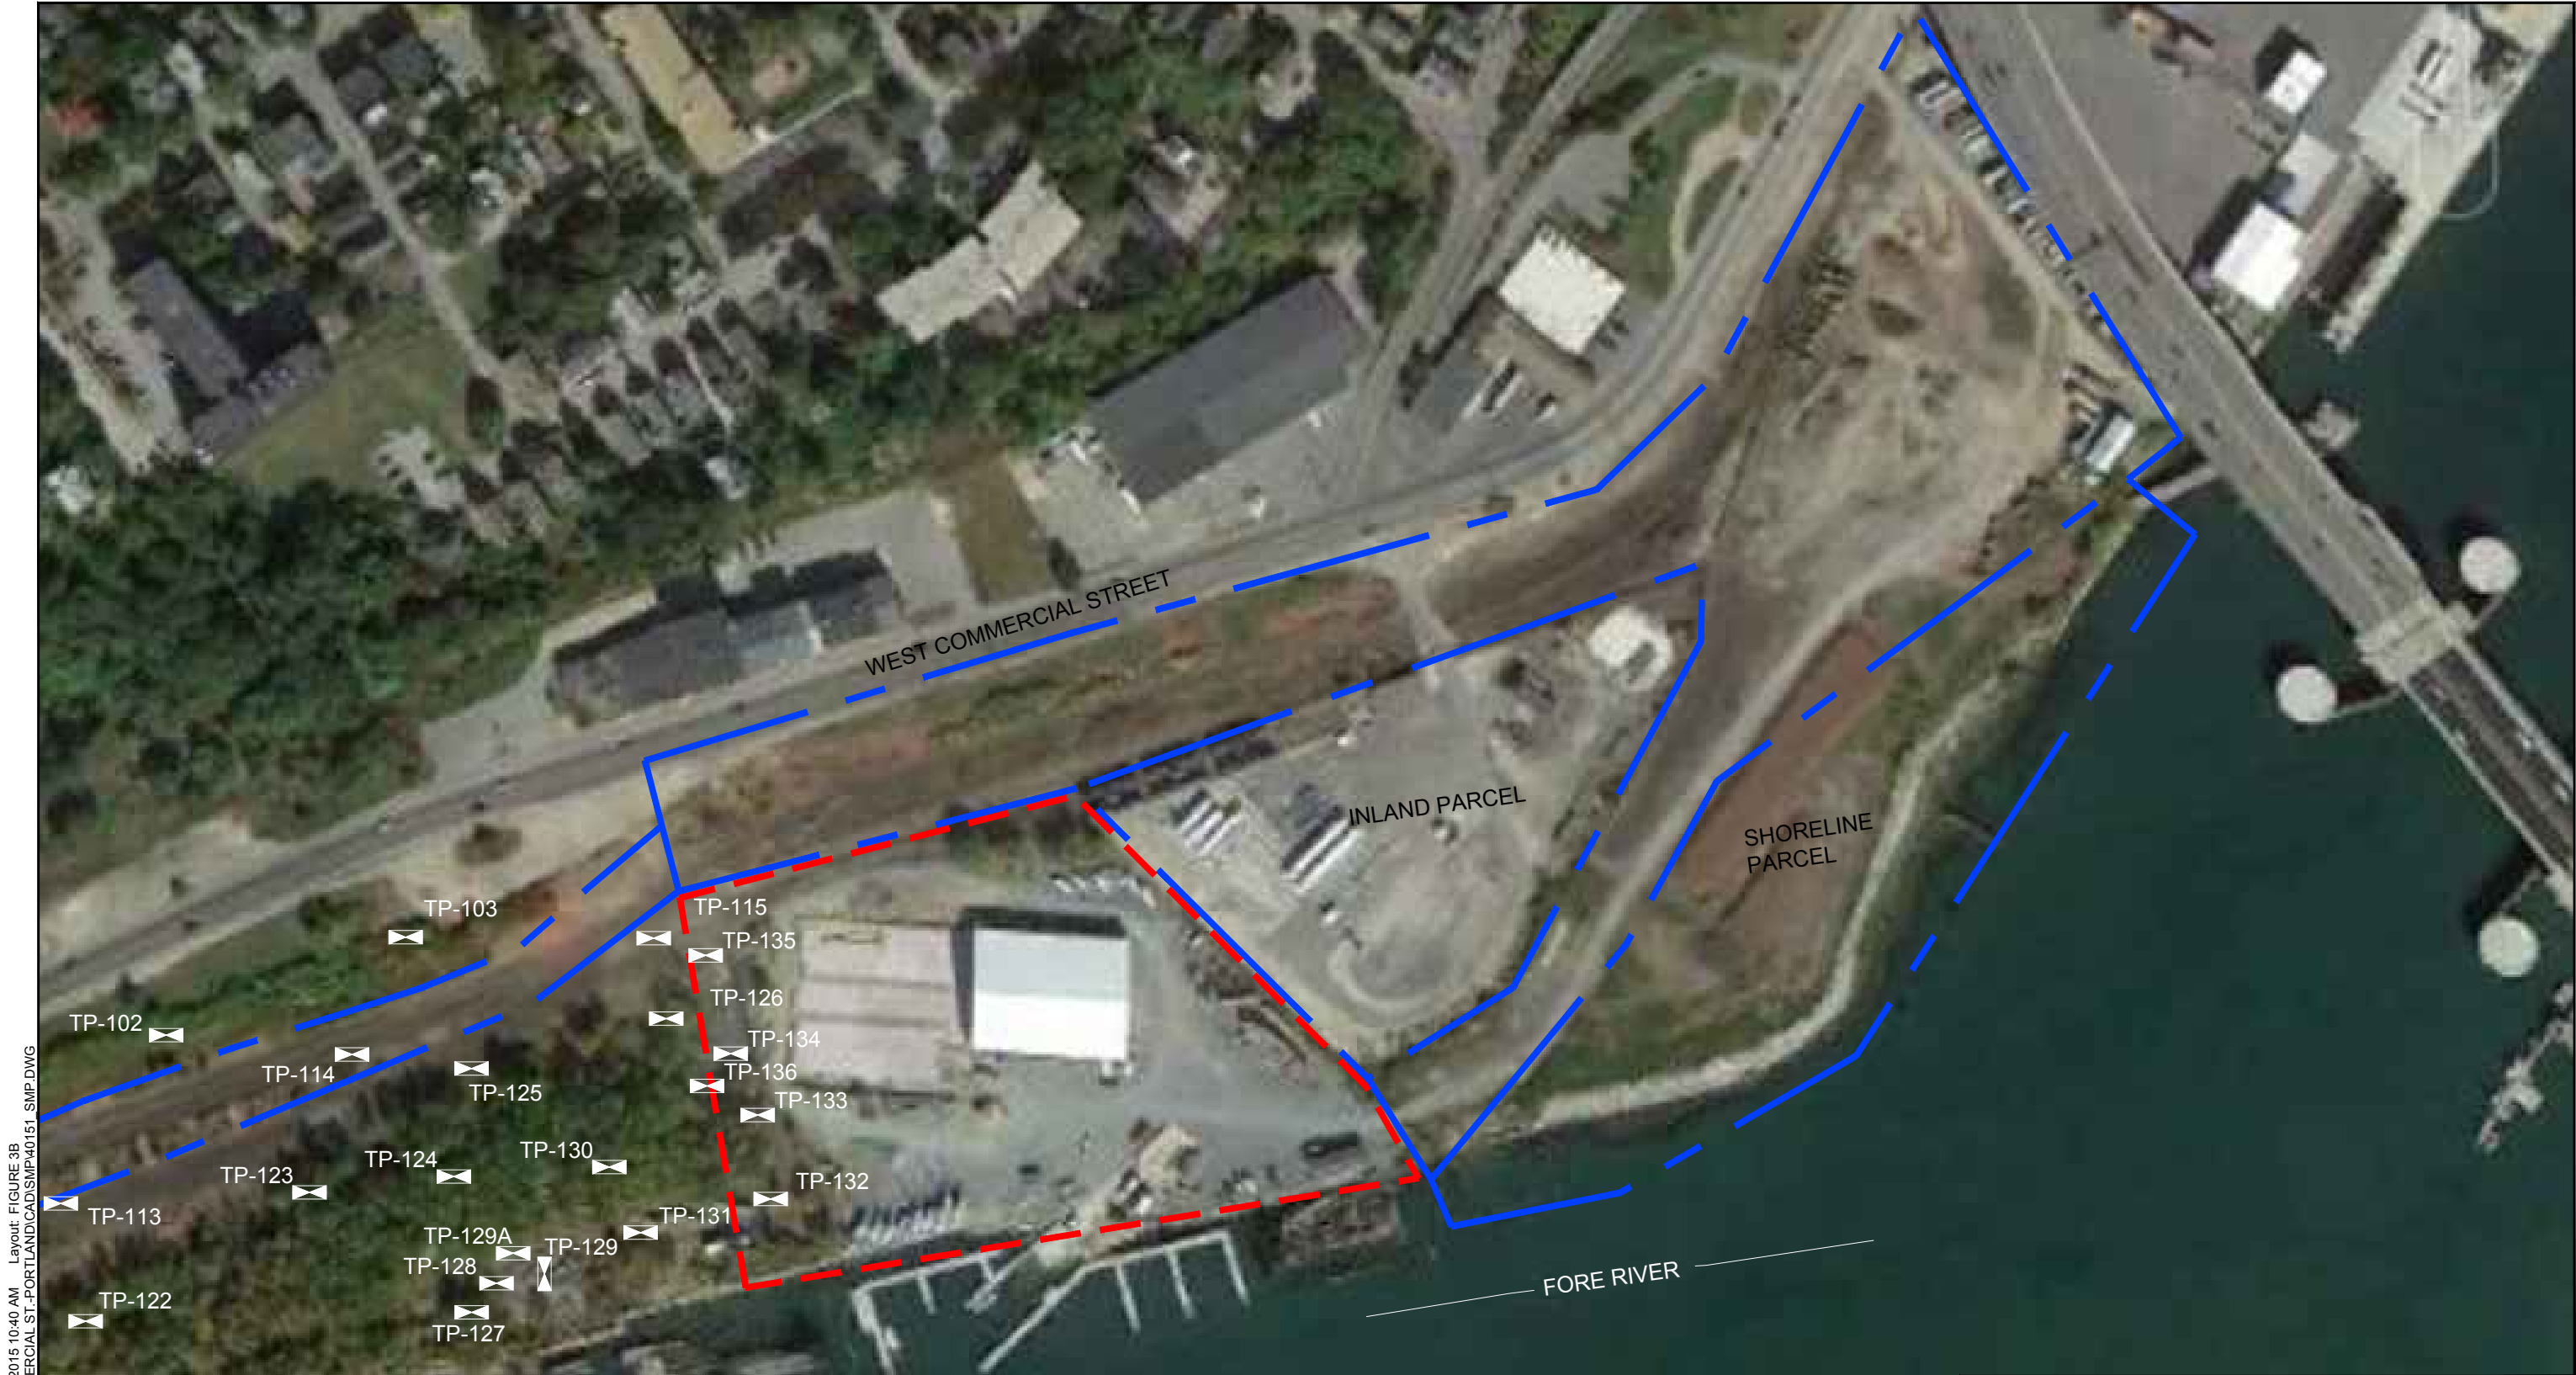
FIGURE 3

1. BASE PLAN OBTAINED FROM GOOGLE EARTH, US DEPT. OF STATE GEOGRAPHER, 2013 GOOGLE.
2. TEST PIT EXCAVATIONS WERE PERFORMED BY MACKENZIE CONSTRUCTION OF WINSLOW, MAINE BETWEEN 19 AND 23 AUGUST 2013. ALL EXPLORATIONS WERE MONITORED BY HALEY & ALDRICH PERSONNEL.
3. TEST PIT LOCATIONS ARE APPROXIMATE AND WERE DETERMINED BY TAPING/PACING DISTANCES FROM EXISTING SITE FEATURES.
4. DESIGNATED PROPERTY BOUNDARIES WERE DETERMINED FROM "BOUNDARY & TOPOGRAPHIC SURVEY, WEST COMMERCIAL STREET," DATED 4 APRIL 2014 PREPARED BY OWEN HESKELL, INC. FOR HNTB & MAINE DOT.

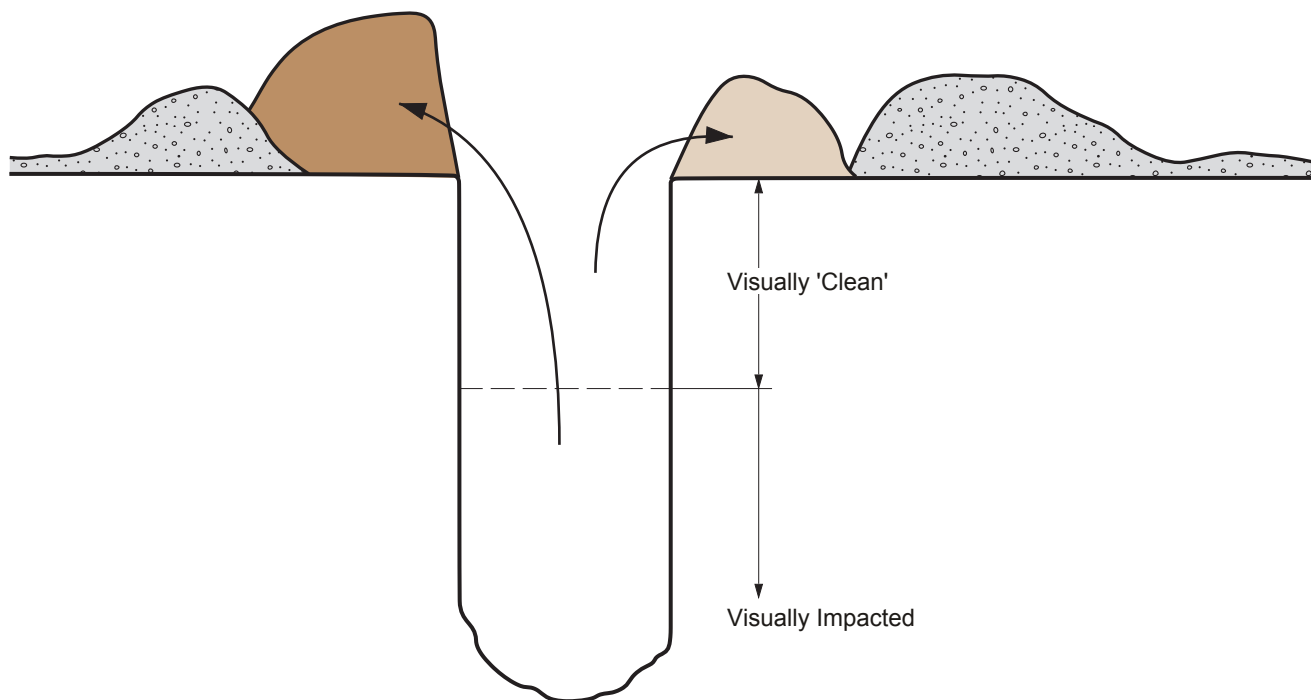
Figure 4
Excavation Protocol
MaineDOT
International Marine Terminal
Portland, ME

If the excavation occurs in an area of pavement or crushed rock, this material is first removed and stockpiled for reuse. Soil removed from the excavation shall be initially-separated based on visual inspection of the soil. Soil removed from the ground surface to a depth where soils are visually impacted with MGP materials shall be placed to one side of the excavation. Rail yard fill material impacted soils excavated from the point of visual staining to the bottom of the excavation shall be placed on the opposite side of the excavation (see Figure 4).

- Visually 'Clean' Soil
- Visually Impacted ('stained') Soil
- Gravel Cover Material

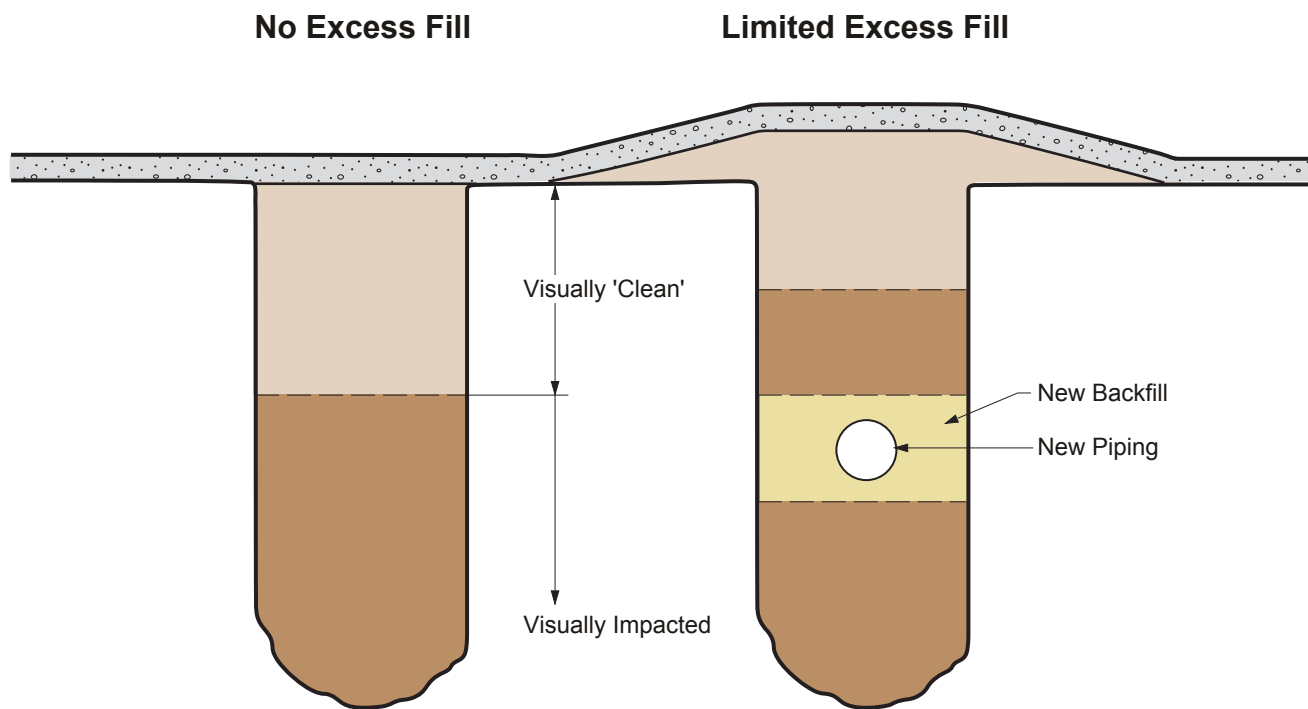
- Visually 'Clean' Soil
- Visually Impacted ('stained') Soil
- Imported Backfill
- Gravel Cover Material
